NATIONAL TRANSPORTATION SAFETY BOARD

Airframe and Engine Exam N757PY

WPR20LA055

Aircraft: N 757PY / Cessna 152

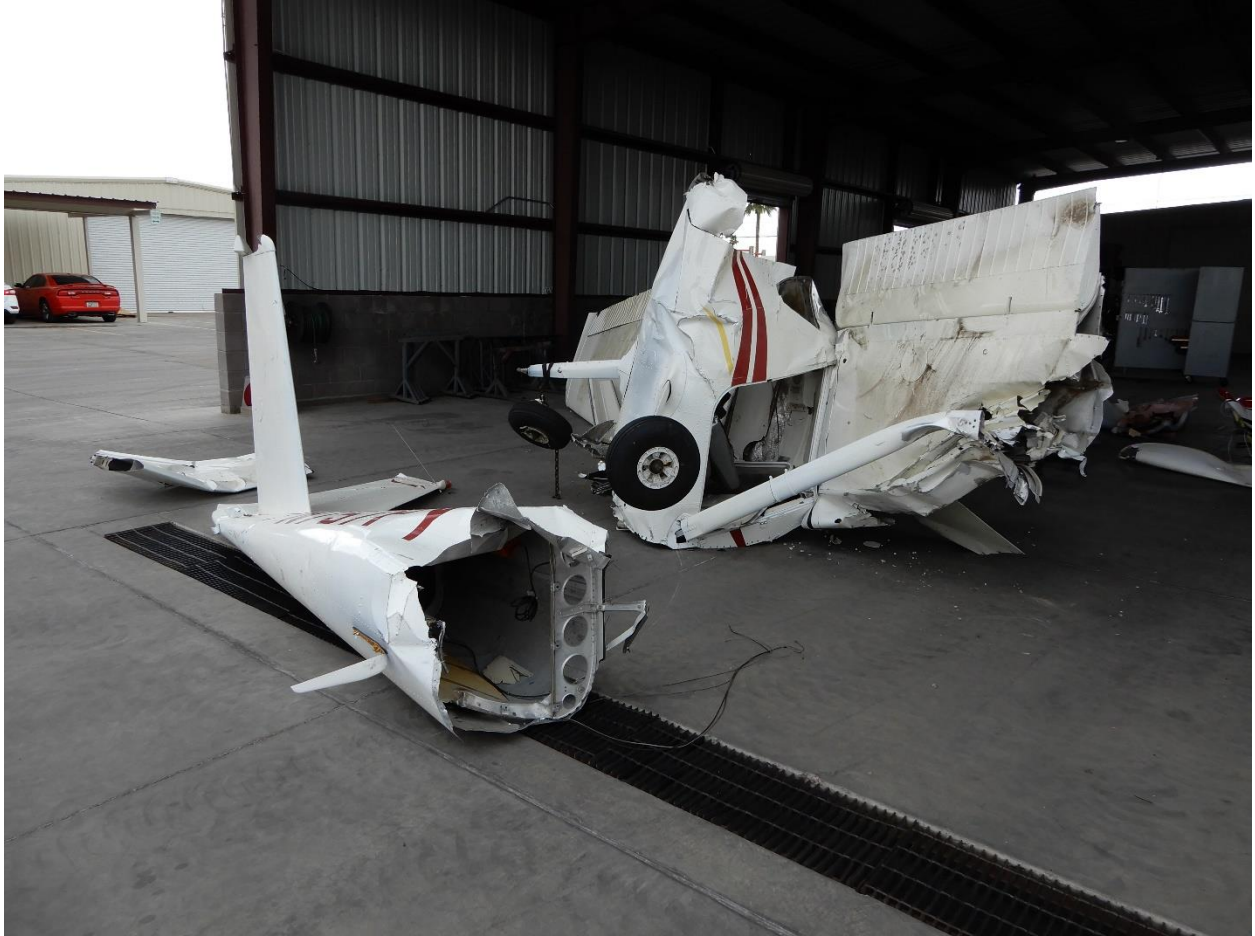
The right door was not attached to the fuselage but recovered. The hinges on the fuselage appeared normal and without damage, suggesting the door was removed during recovery. The sheet metal forward of the front door post appeared to have been cut for recovery. The right-wing strut remained attached to the fuselage and the wing and had a large circumferential dent near the tie-down ring that pushed the strut aft. The sheet metal aft of the right door exhibited dents and wrinkling. The fuselage was cut about 30 inches aft of the rear door post, separating the aft fuselage and empennage. All control cables to the empennage were severed. The right-side aft fuselage exhibited denting and wrinkling of the sheet metal near the area where the aft fuselage was separated, suggesting that this area received damage from the accident and breaching the fuselage. The remaining aft fuselage area exhibited minor damage with small dents and wrinkling sheet metal.

Figure 1. N757PY, right-side view.

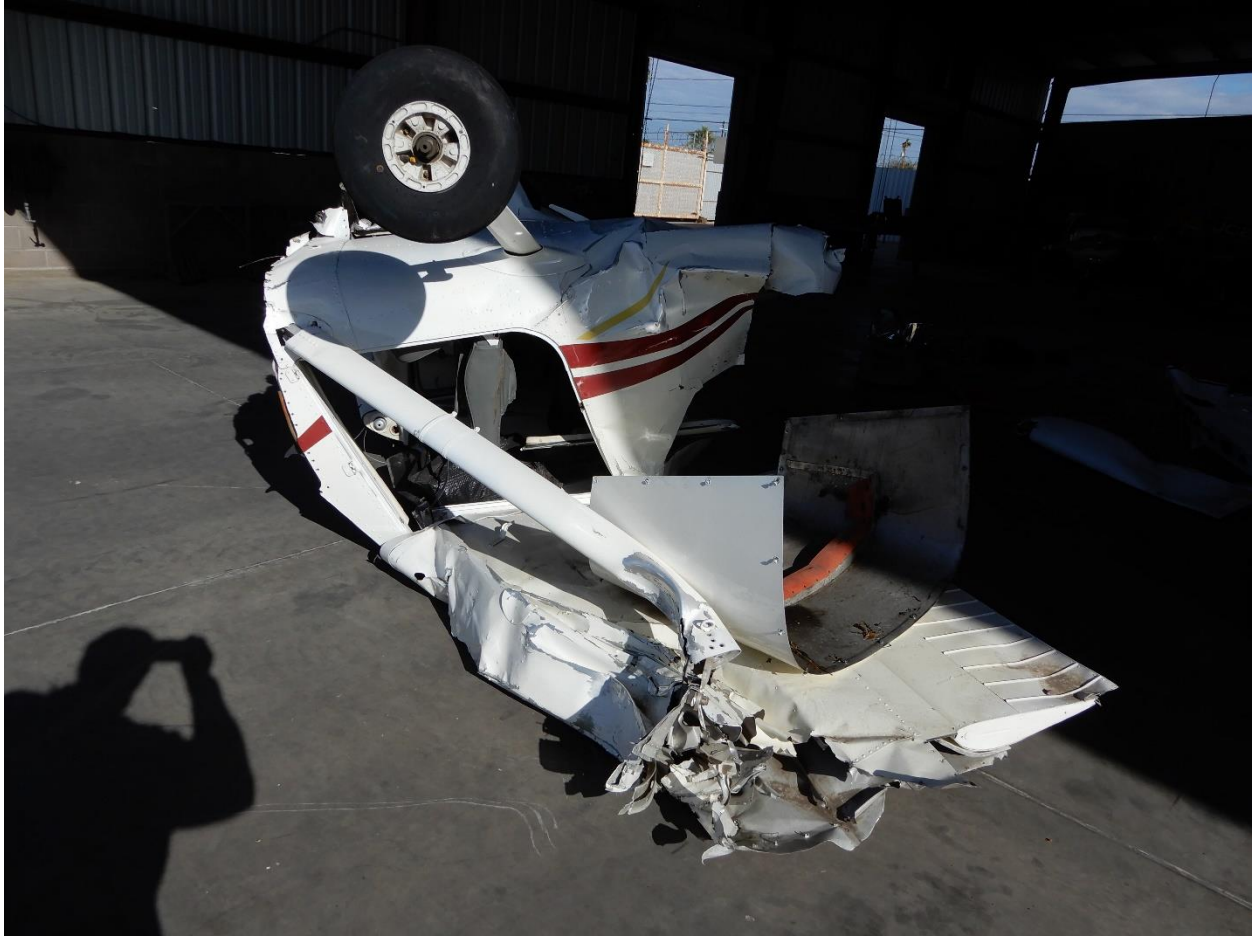
The right wing was separated from the airplane just outboard of the wing strut area. There was substantial damage from the leading edge aft to about mid-chord. The wing strut remained attached at both ends and had substantial damage near the wing mount. The inboard section of right wing remained attached to the upper fuselage at the attachment points. The right flap remained attached to the right wing and appeared in the full up position. The flap exhibited minor damage to the top and bottom but was pushed aft into the fuselage. The separated section of right wing exhibited substantial damage at the separation area with damage to the leading edge extending aft past the wing spar. The aileron remained attached to the right wing at the hinges and articulated up and down with moderate force. The bottom and top of the right wing exhibited damage with wrinkling, denting and punctures throughout its span. The wing tip remained attached and exhibited wrinkling and denting. The right fuel cap remained secure to the fuel cap. When opened the right wing contained a clear fluid that tested positive for water. The right fuel tank and cap exhibited a brownish coating and corrosion that appeared to be rust. The rubber seal was soft and pliable. The right fuel tank was removed for further examination. The bottom of the right tank exhibited corrosion.

Figure 2. N757PY, right-side view of right wing and strut.

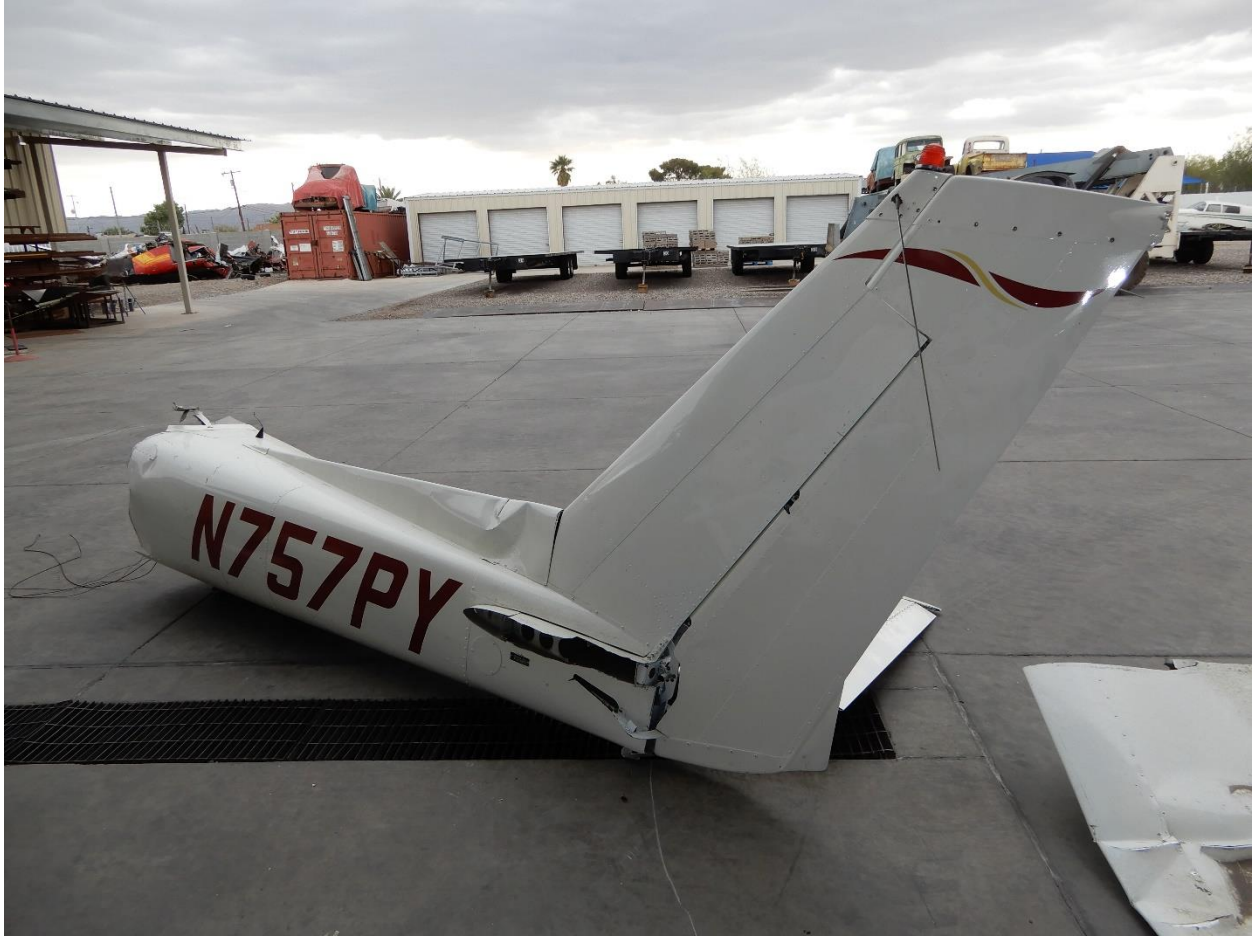
The left side of the aft fuselage exhibited minor damage from the end of the empennage to the area where the aft fuselage was separated from the forward fuselage area. The left-side fuselage area behind the left door post was extensively damaged with the sheet metal distorting outwards and the roof top area crushing downwards. The left door remained attached to the fuselage at the hinges.

Figure 3. Left-side view of aft fuselage and empennage.

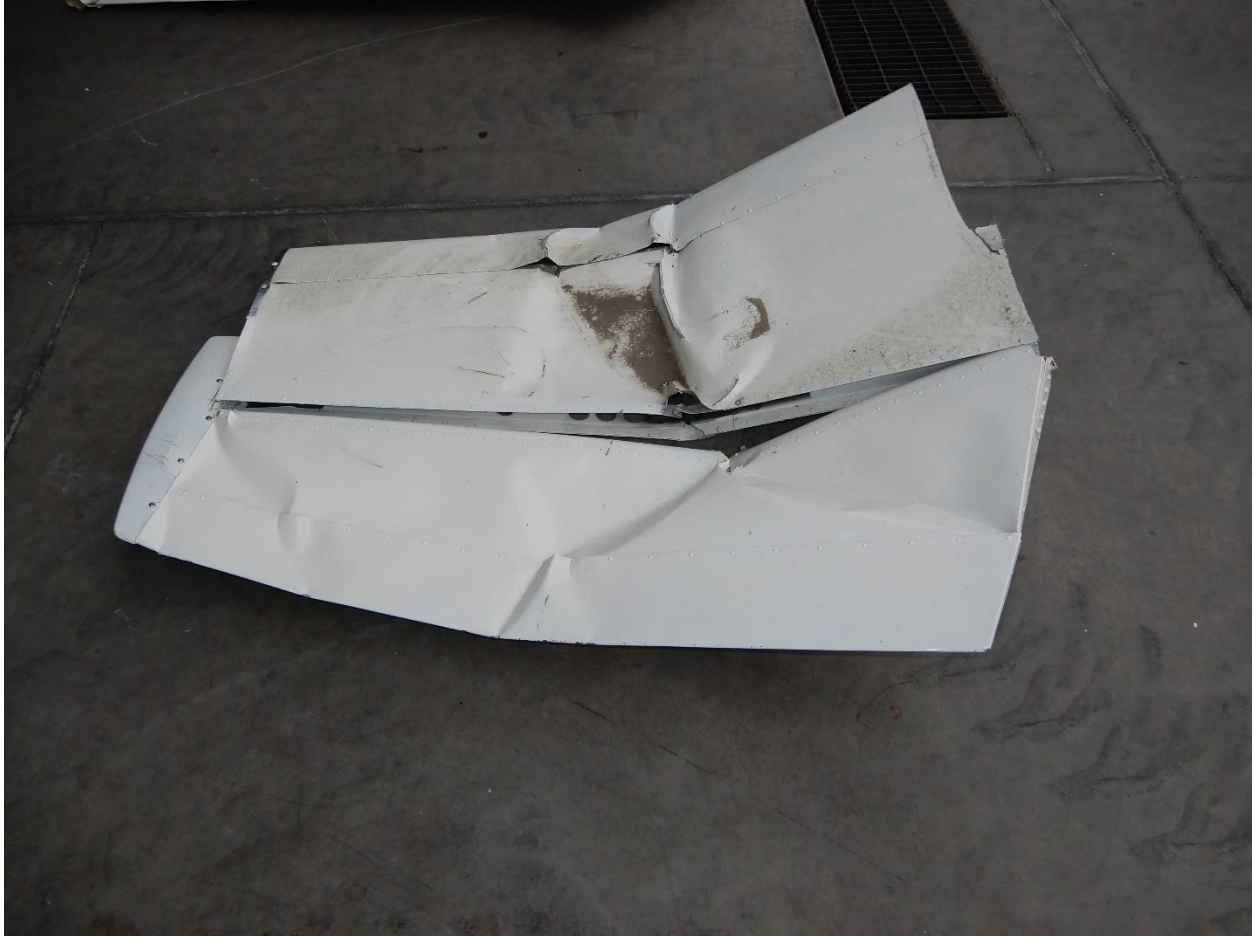
The right horizontal stabilizer remained attached to the empennage and exhibited minor damage. The right elevator remained attached to the right horizontal stabilizer and exhibited minor damage. The trim tab remained attached to the right elevator and exhibited minor damage, and appeared to be set in a near neutral setting. The vertical stabilizer and rudder remained attached to the empennage. The right side of the vertical stabilizer exhibited minor damage. The right side of the rudder exhibited minor damage. The left side of the vertical stabilizer exhibited minor damage. The left side of the rudder exhibited minor damage with a small wrinkle in the sheet metal near the top hinge. The left horizontal stabilizer and elevator were cut during recovery. Both the horizontal stabilizer exhibited extensive damage to the top and bottom surfaces. The left horizontal stabilizer exhibited upward bending about mid-span with wrinkling around the bends. The left elevator exhibited upward bending with wrinkles running span-wise and chord-wise.

Figure 4. Left horizontal stabilizer and elevator.

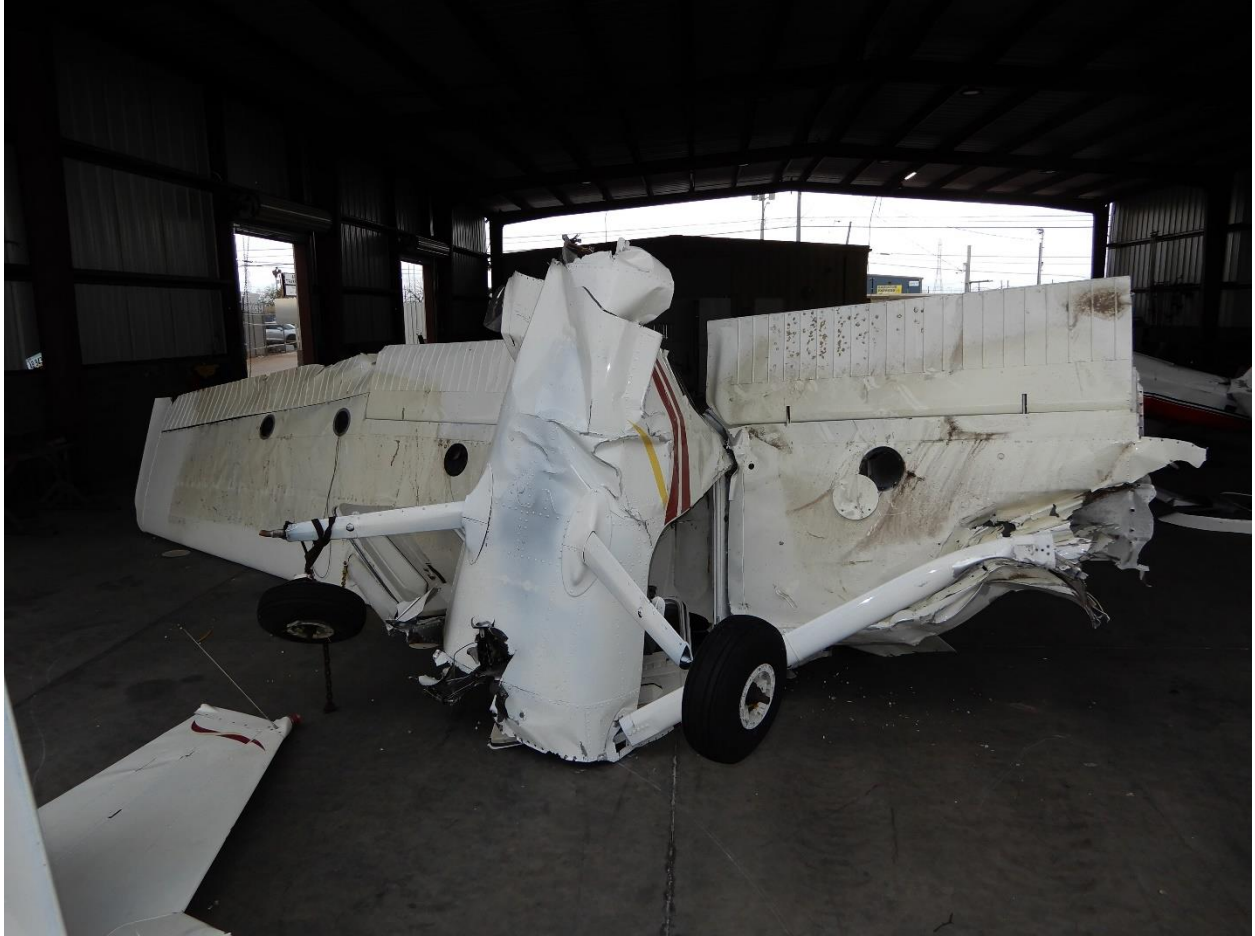
The bottom of the fuselage, from the main landing gear area to the point where the aft fuselage was separated, exhibited substantial damage with large dents and wrinkling of the sheet metal.

Figure 5. Bottom view of fuselage and wings.

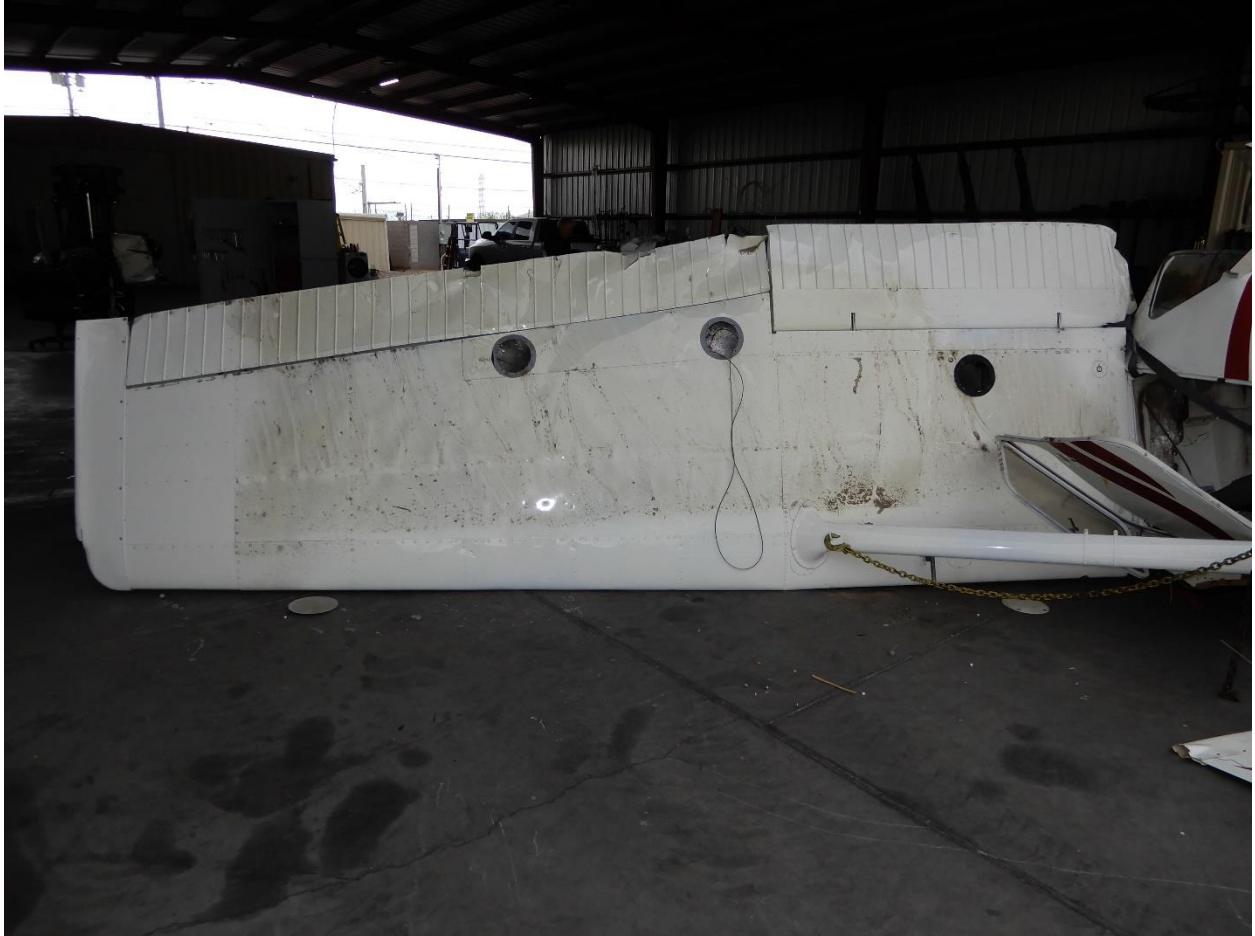
The left wing remained attached to the fuselage at the mounting points. The left-wing strut remained attached to the wing and the fuselage and exhibited minor damage. The left aileron remained attached to the wing at the hinges and exhibited substantial damage. The aileron articulated up and down to the full travel with moderate force. The left flap remained attached to the wing at the hinges and appeared to be in the full up position. The flap had damage throughout its span. The upper surface of the left wing exhibited substantial damage with extensive wrinkling and dents running chord-wise from the wing root out to about mid-span. The upper

surface, from mid-span to the wing tip, exhibited minor damage. The lower wing surface exhibited minor damage throughout its span. The wing tip remained attached to the wing and exhibited minor damage. The left fuel cap remained secured to the wing. The rubber seal was soft and pliable. The fuel port had light corrosion and rust on it and the chain. The fuel tank was dry with no evidence of water intrusion.

Figure 6. Bottom view of left wing, aileron, and flap.

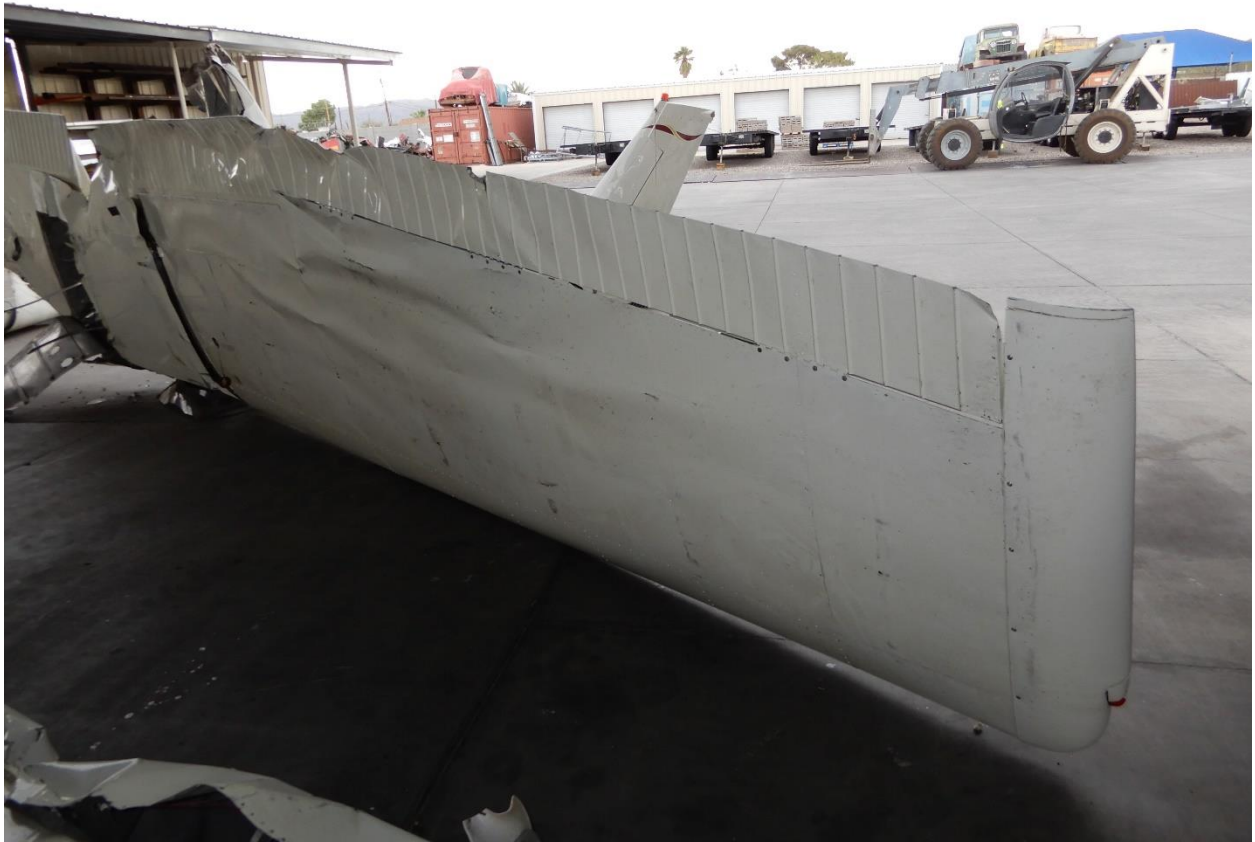
Figure 7. Top view of the left wing, aileron, and flap.

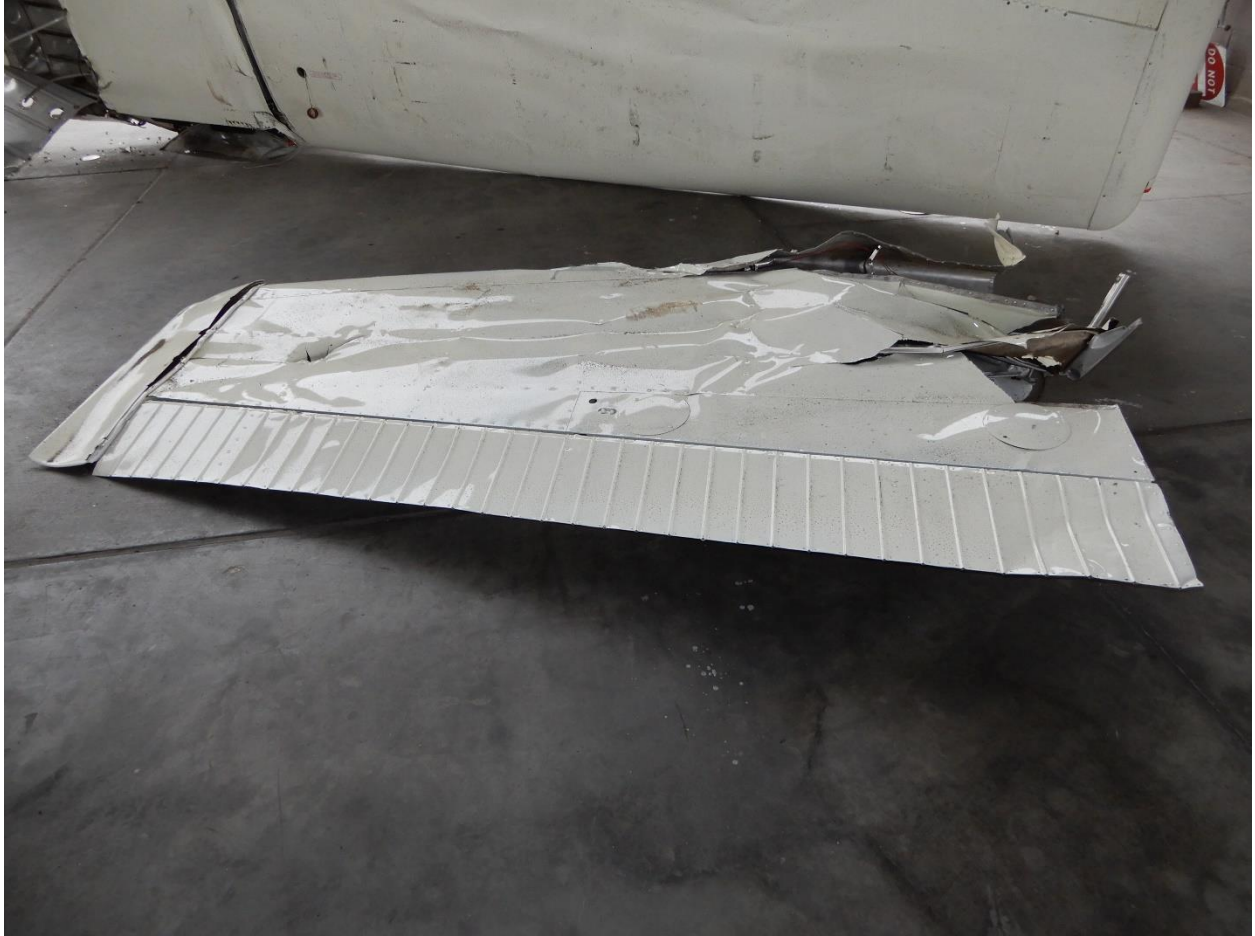
Figure 8. Bottom view of the separated section of the right wing and aileron.

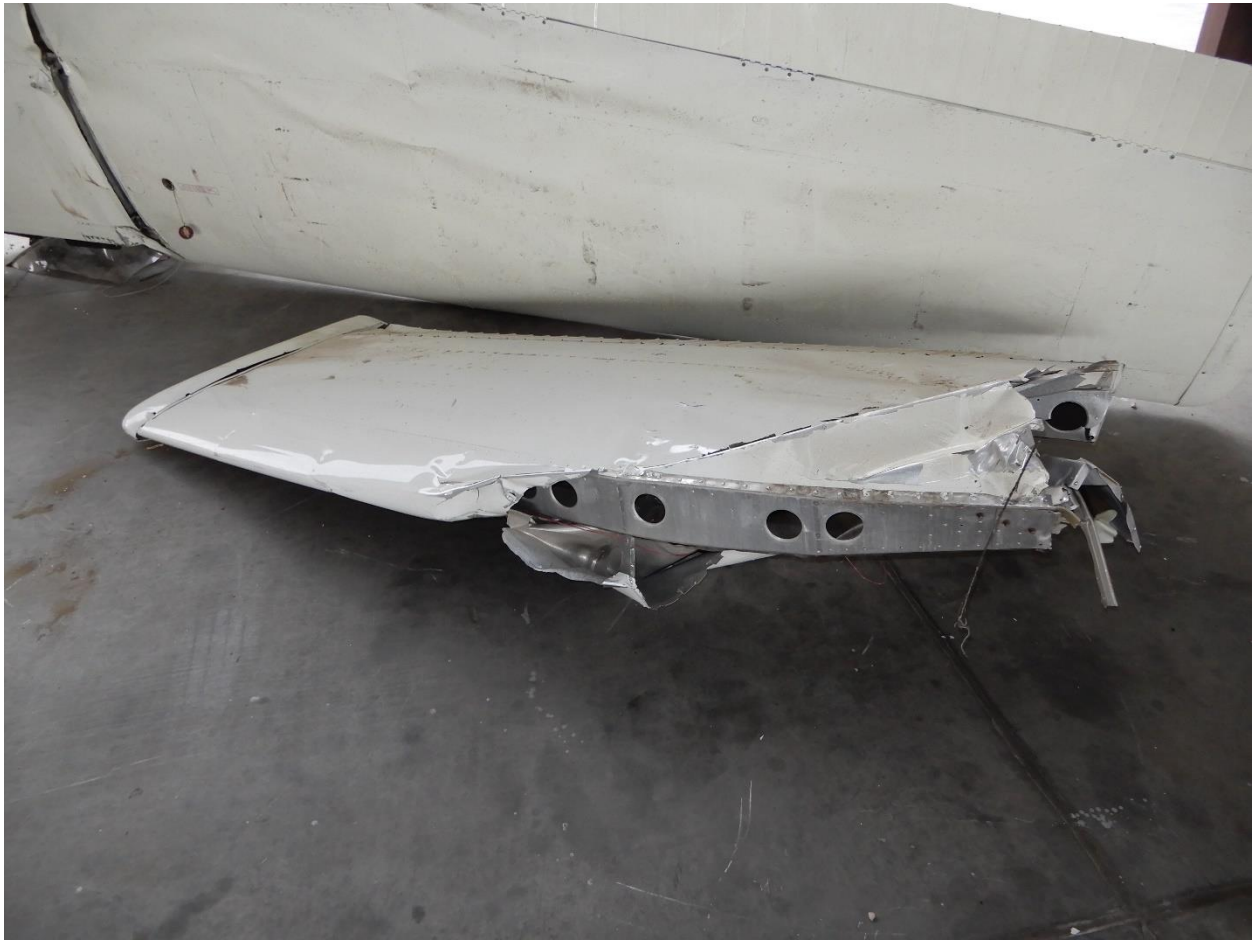
Figure 9. Top view of the separated section of the right wing, showing the leading edge.

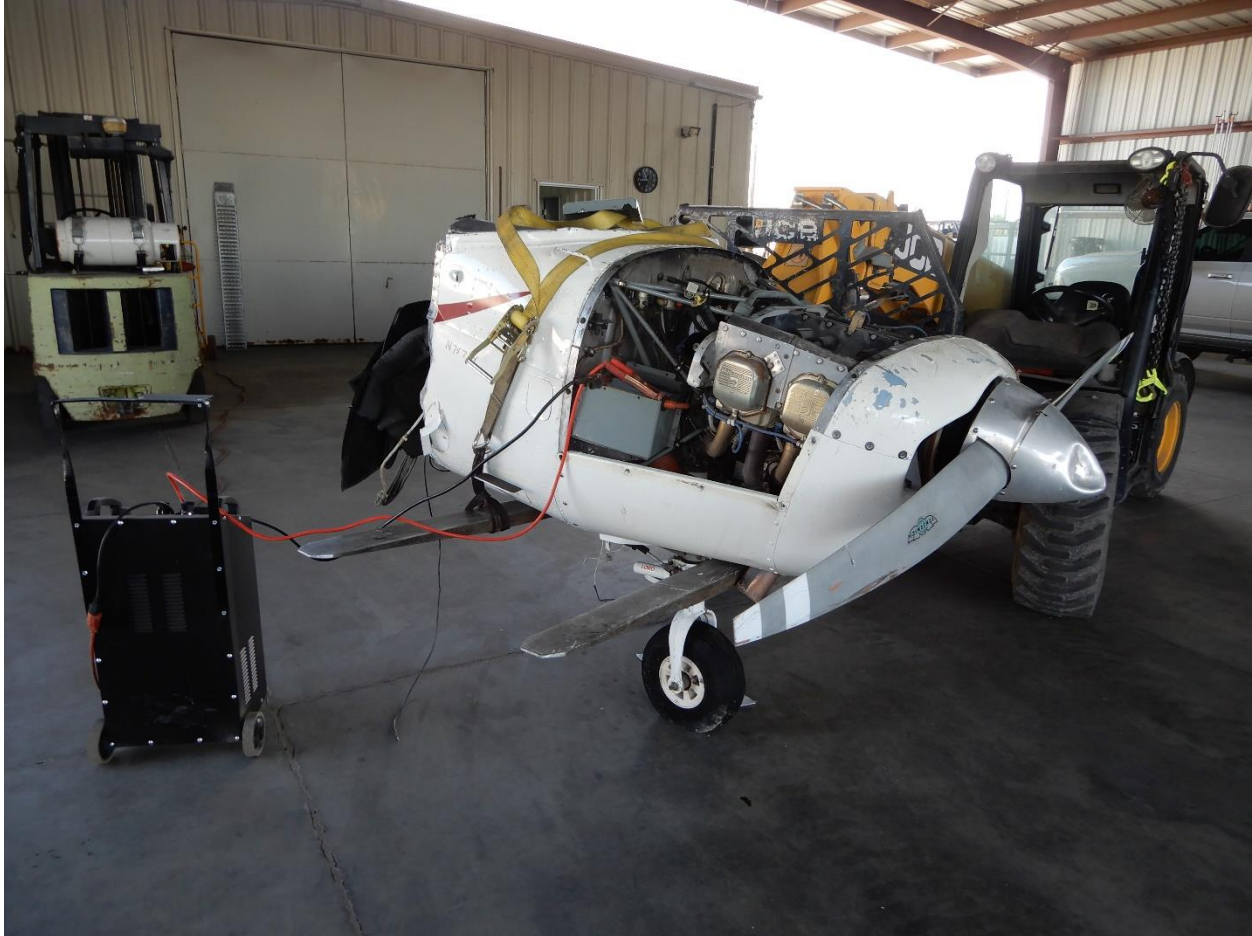
The engine, firewall and instrument panel were separated from the fuselage and exhibited substantial damage. The upper cowling was separated from the engine nacelle and recovered. The lower cowling remained attached to the engine nacelle and exhibited minor damage. The propeller remained attached to the engine and exhibited aft bending to one blade to about 4 inches aft of normal. The other blade exhibited minor damage. The metal spinner exhibited minor damage with one dent near the tip.

Figure 10. Right view of the engine, engine nacelle, and propeller.

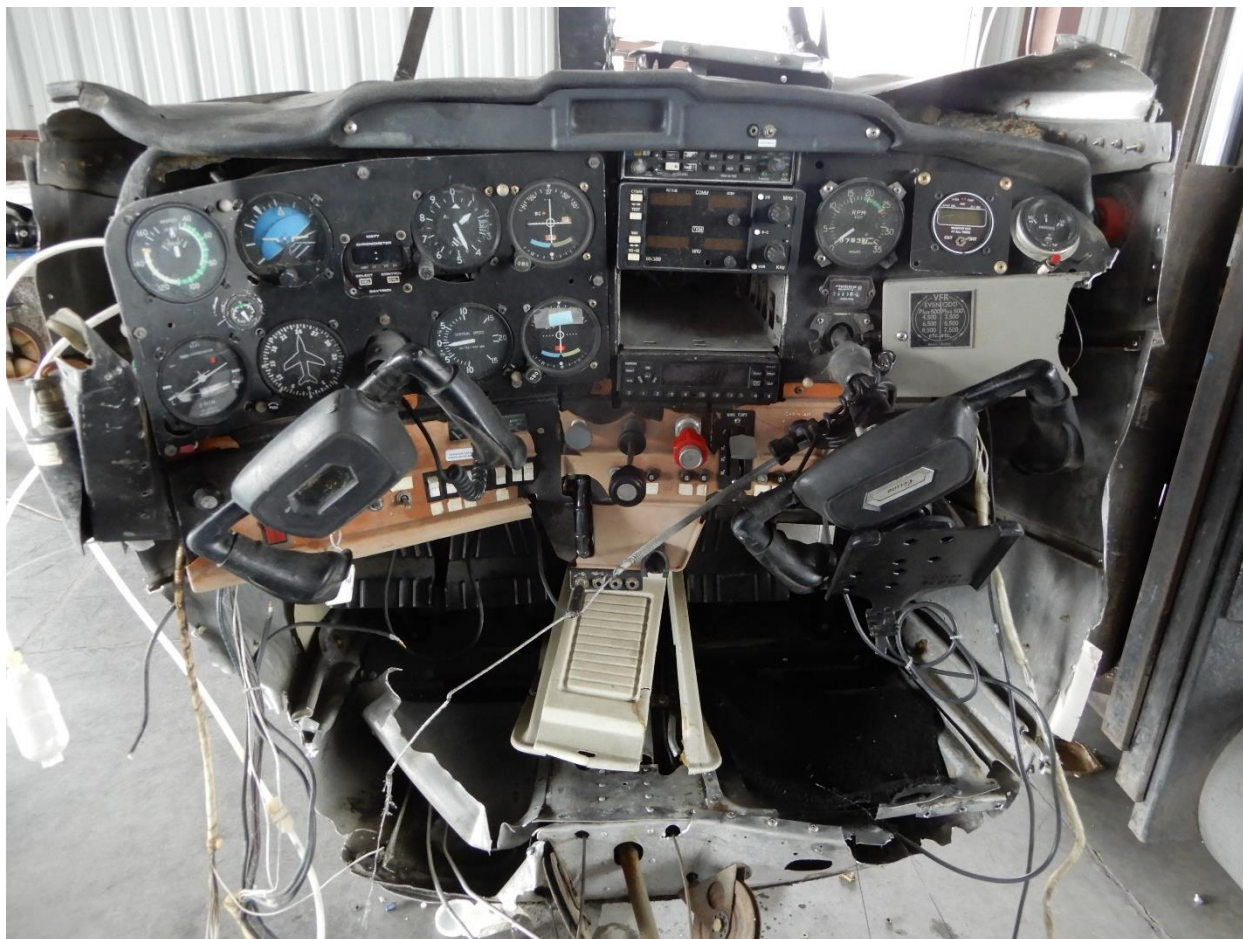
The cabin area was not compromised. The instrument panel remained attached to the fuselage and exhibited substantial damage. The left and right control yokes were bent. The throttle

remained secured to the throttle quadrant and moved in and out with moderate force. The mixture remained secured to the quadrant and moved freely. Flap lever was secure and in the up position. The trim knob remained secure with no indication of the setting noted. A Hobbs meter was mounted on the instrument panel and read: 2883.3. The tachometer read: 8783.7. The rudder pedals remained attached to this section of the airplane. The key remained in the ignition switch and was in the BOTH position.

Figure 11. View of the instrument panel and throttle quadrant.

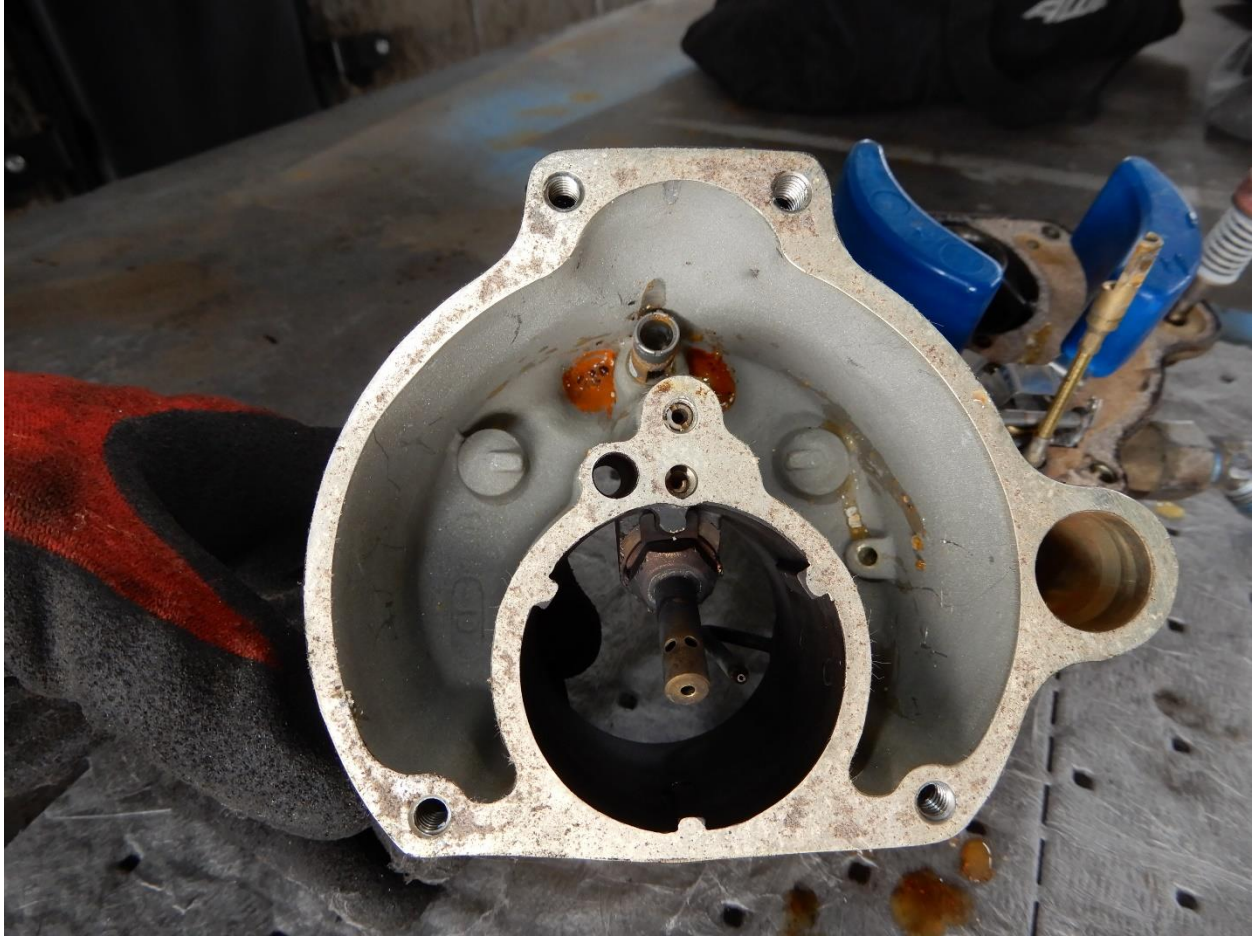
The upper portion of the carburetor above the bowl contained corrosion. The carburetor bowl was dry but contained a rust-colored sediment at the lowest portion of the bowl. The floats

exhibited normal appearance and moved freely. Contaminants were observed in the needle area of the float assembly area. The accelerator pump piston and well was clean. The mixture cable remained attached the carburetor and the mixture control handle.

Figure 12. Carburetor bowl showing rust colored sediment at the bottom of the bowl.

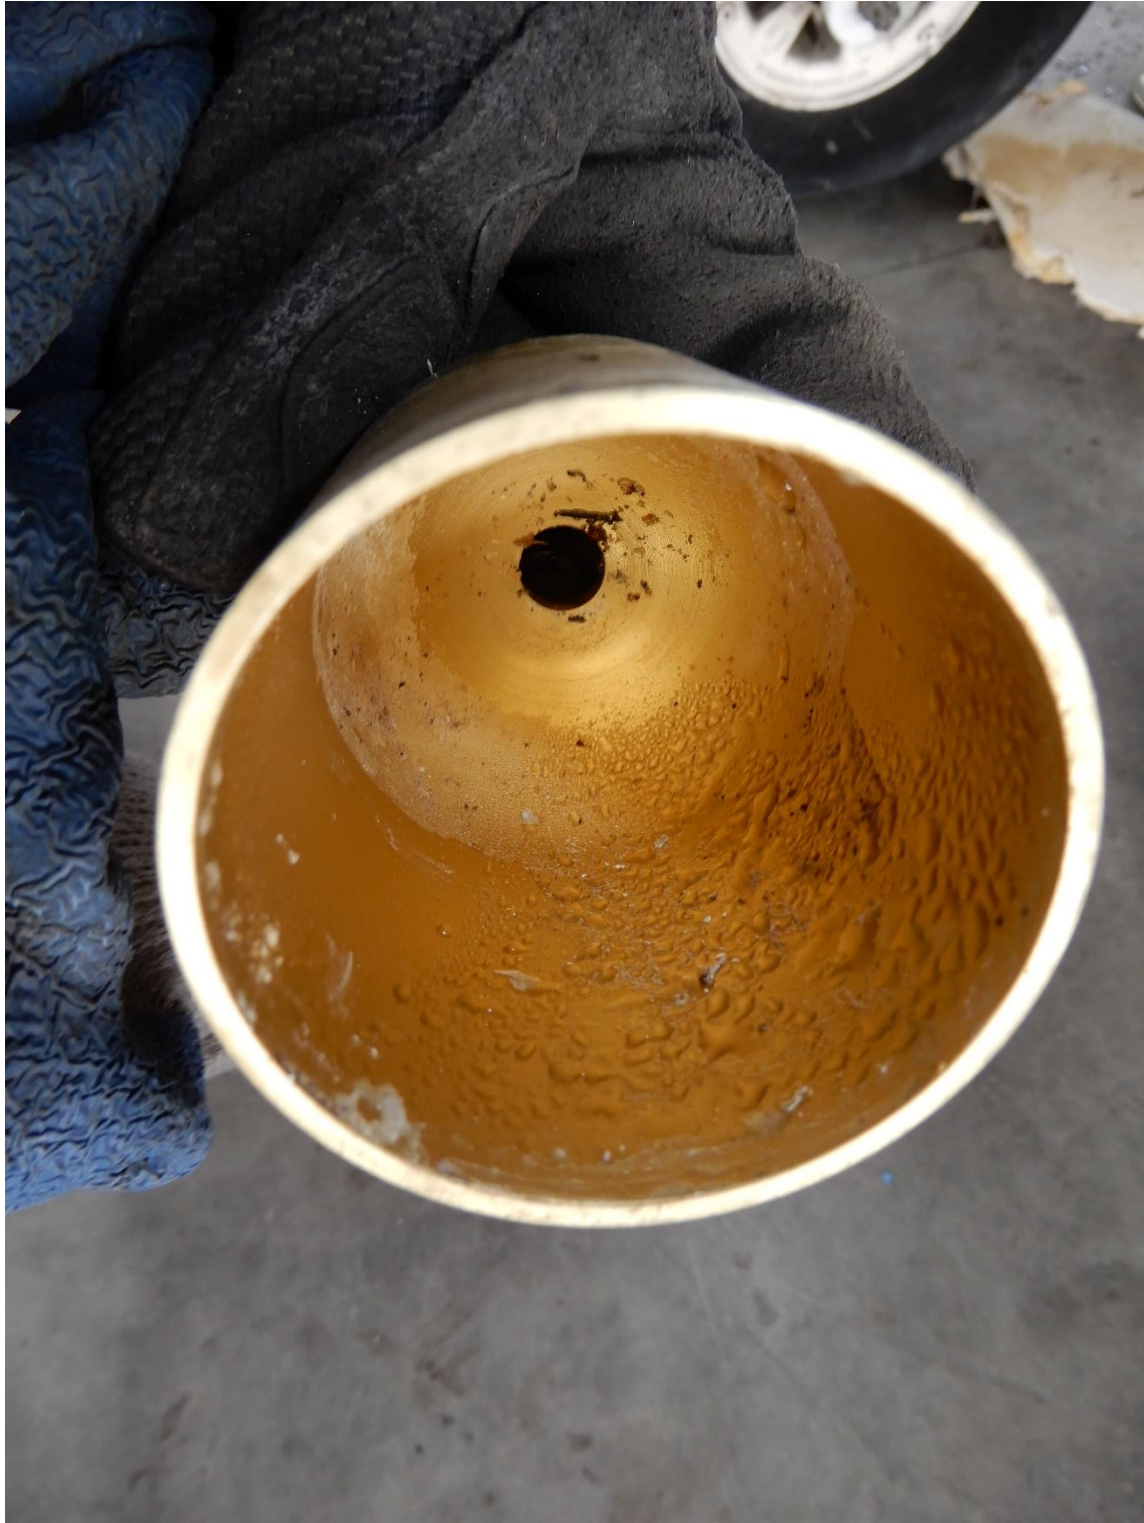
The gascolator remained attached to the firewall. When opened the gascolator bowl was dry and contained contaminants and residue. The gascolator screen filter contained a white powdery residue that obstructed about 30% of the screen surface. The stem running the bottom of the gascolator bowl had a large amount of corrosion attached to it. The fuel tubing from the gascolator to the fuel selector switch was secured at both ends.

Figure 13. Inside view of the gascolator bowl, showing water residue.

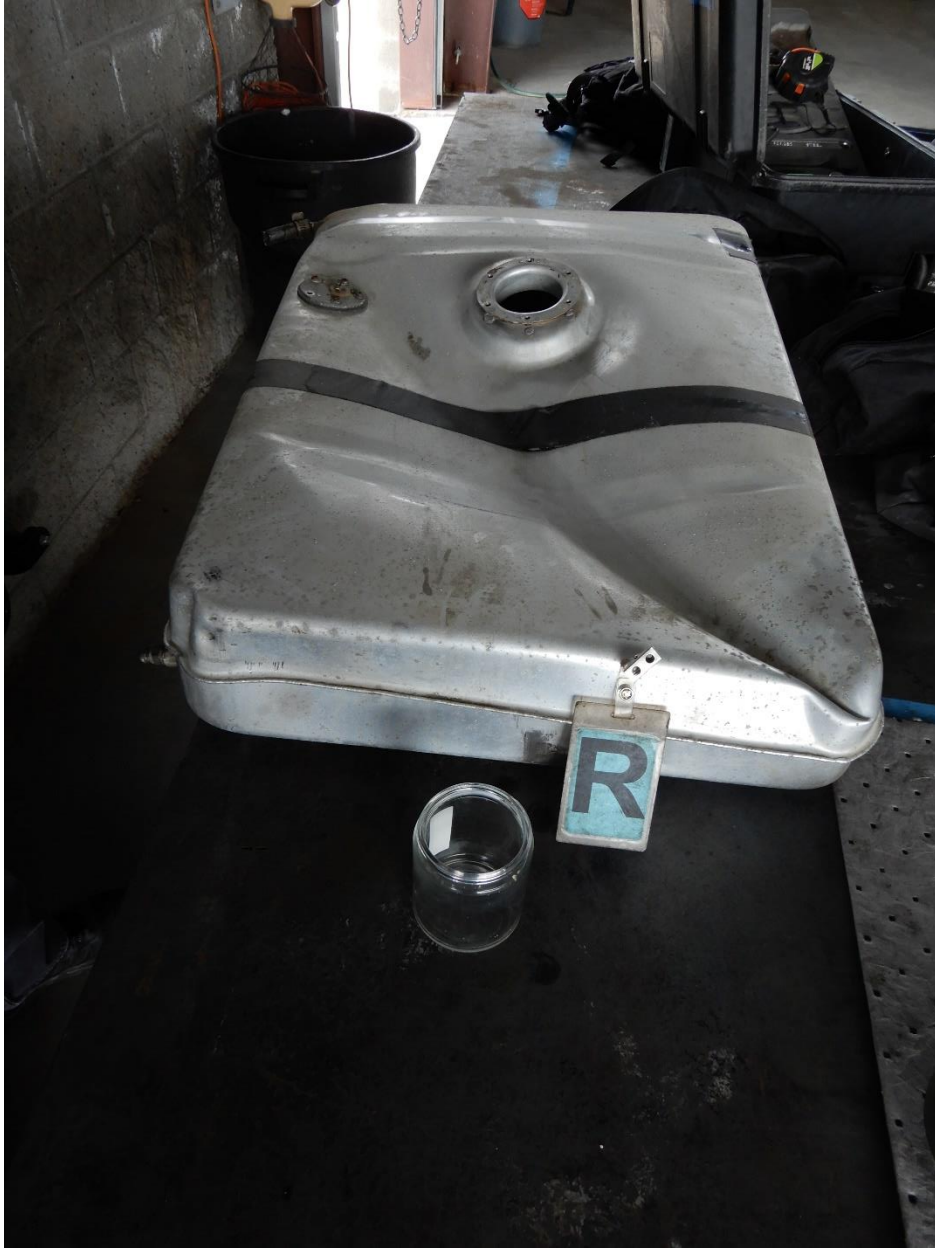
- Engine data plate info:
 - Eng no. L-20213-15
 - SE792NW
 - Takeoff 5 min: 118 at 2800 RPM
 - Normal: 105/110/112/115 H.P at 2400, 2550, 2600, 2700 RPM
 - Spark Advance: 20°
- Evidence of water was found in the right fuel tank, gascolator, carburetor inlet hose and carburetor bowl.

Figure 14. Right-wing fuel tank, showing glass jar with fluid removed from tank.

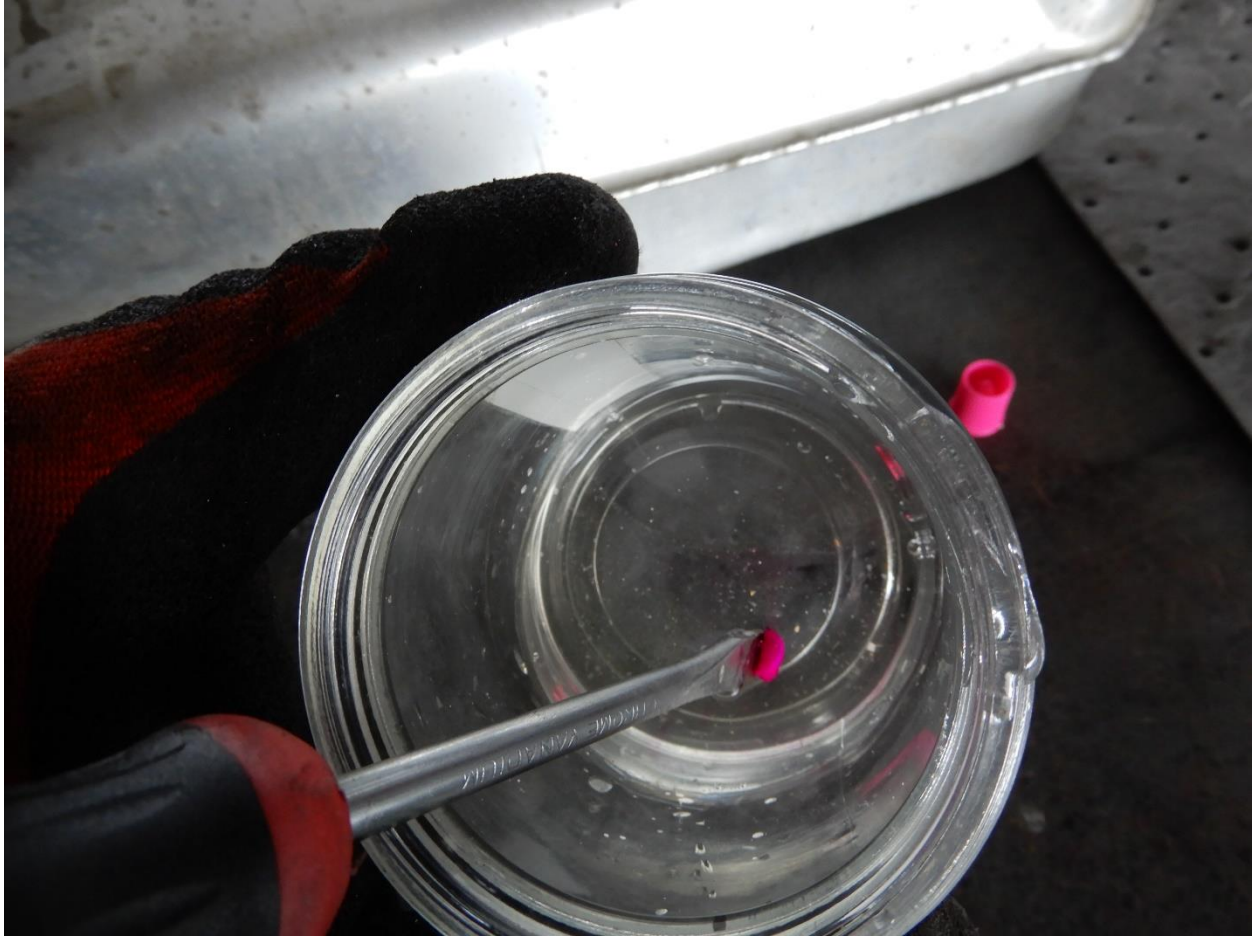
Figure 15. Fluid removed from right-fuel tank with Sargel compound indicating the presence of water.

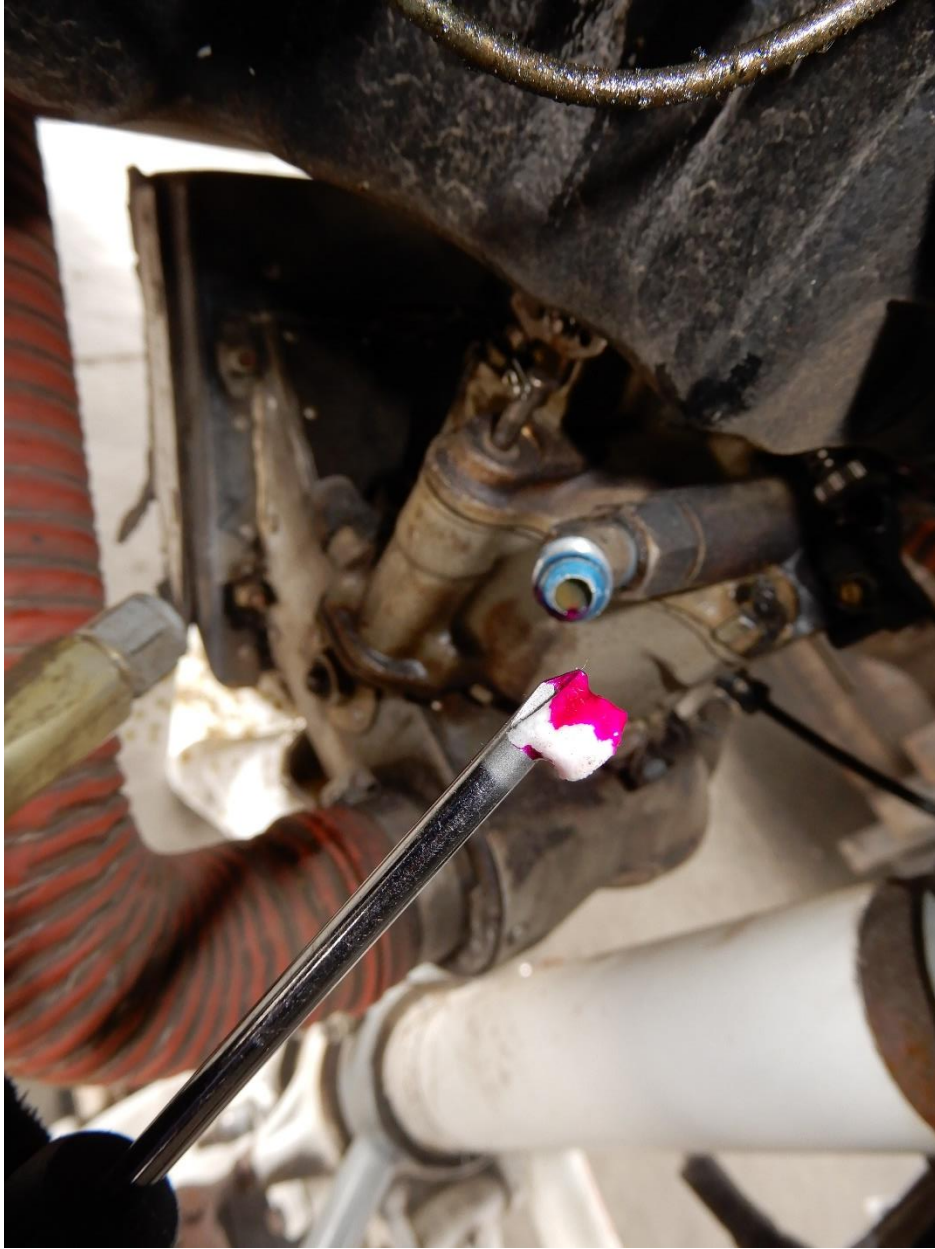
The carburetor, model 4A-3PA, serial number 75B-64415, remained attached to the intake manifold. The fuel hose from the gascolator to the carburetor remained secured at both ends. When removed, there was a rust-colored liquid trapped inside the hose, at the carburetor, that tested positive for water. The throttle cable remained attached to the throttle valve arm and the throttle control handle. The throttle cable from the firewall to the carburetor was bent and restricted the throttle from free movement and limited the travel of the throttle cable. The throttle arm for the intake butterfly valve was loose and moved fore and aft about 1/16"

Figure 16. Fuel line to the carburetor, showing presence of water.
